SEWER SYSTEM MANAGEMENT PLAN

San Bernardino Community College District

June 2016

**Prepared by:
ITF & Associates Inc.
11278 Los Alamitos Blvd., #354
Los Alamitos, CA 90720
(800) 797-9483**

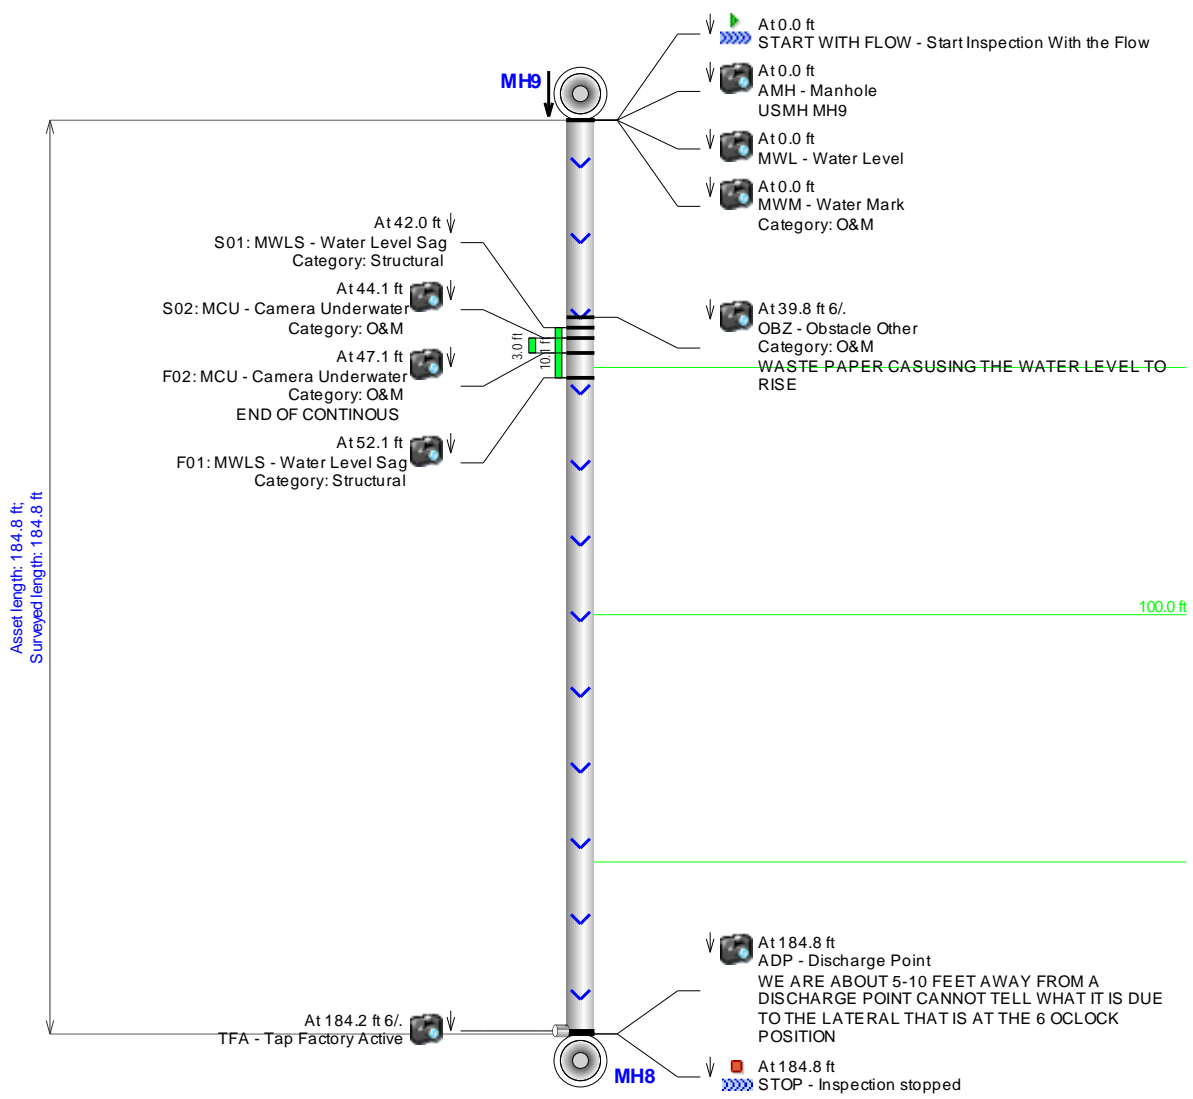
Main Inspection with Pipe-Run and Scoring

Project Name:	Pipeline segment ref:	City:	Street:
CRAFTON HILLS COLLEGE	MH9-MH8	YUCAIPA	CAMPUS DRIVE
Start date/time:	Width:	Height:	Material:
9/29/2015		8	RCP
Location code:	Direction:	Length surveyed:	Weather:
C	Downstream	184.8	1
Media label:

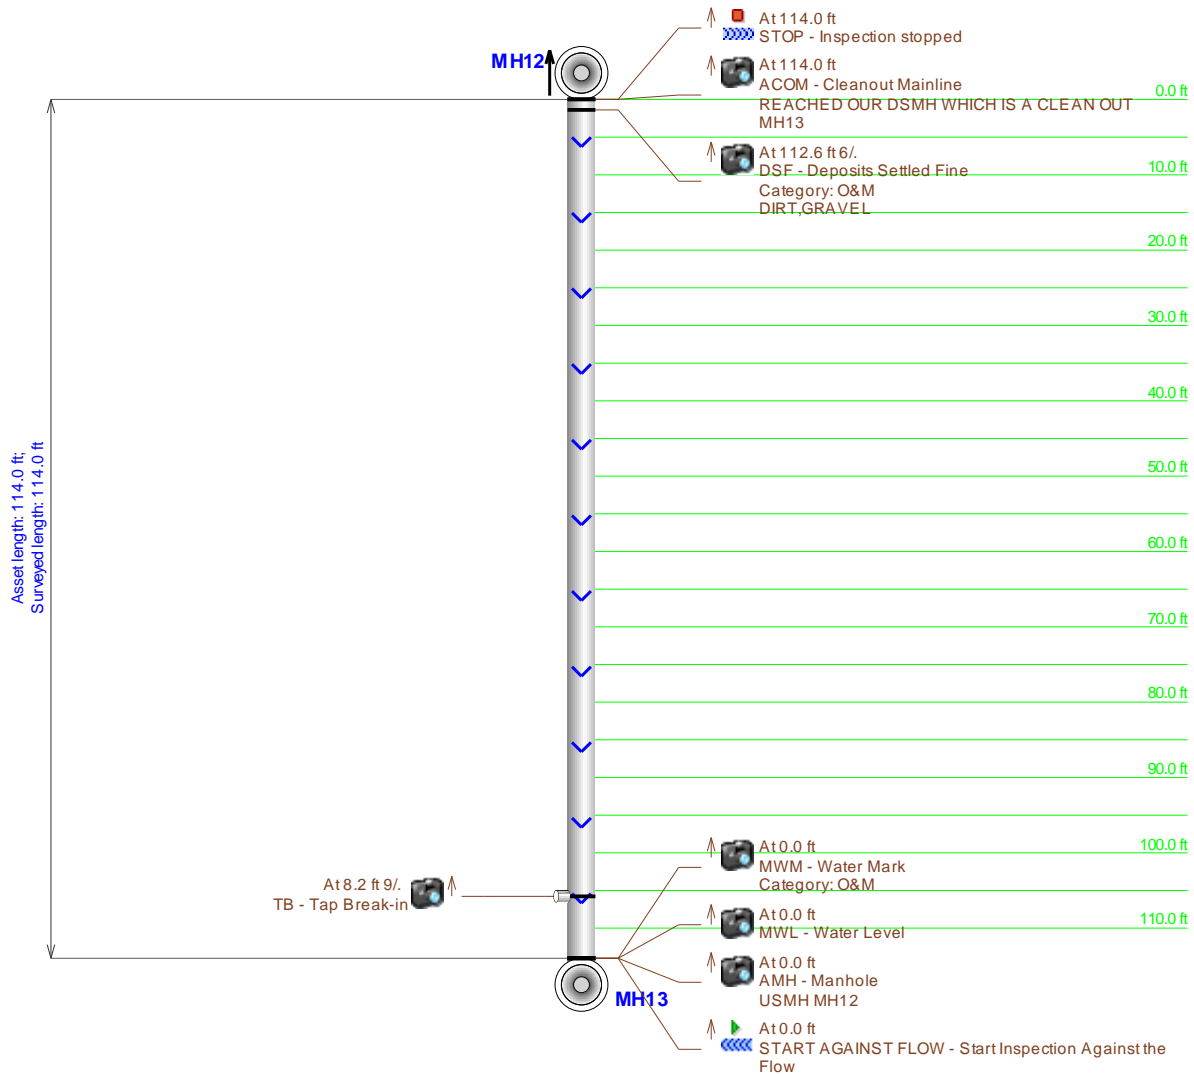
Main Inspection with Pipe-Run and Scoring

Project Name:	Pipeline segment ref:	City:	Street:
CRAFTON HILLS COLLEGE	MH12-MH13	YUCAIPA	PARKING LOT B
Start date/time:	Width:	Height:	Material:
10/3/2015		8	RCP
Location code:	Direction:	Length surveyed:	Weather:
G	UPSTREAM	114.0	1
Media label:

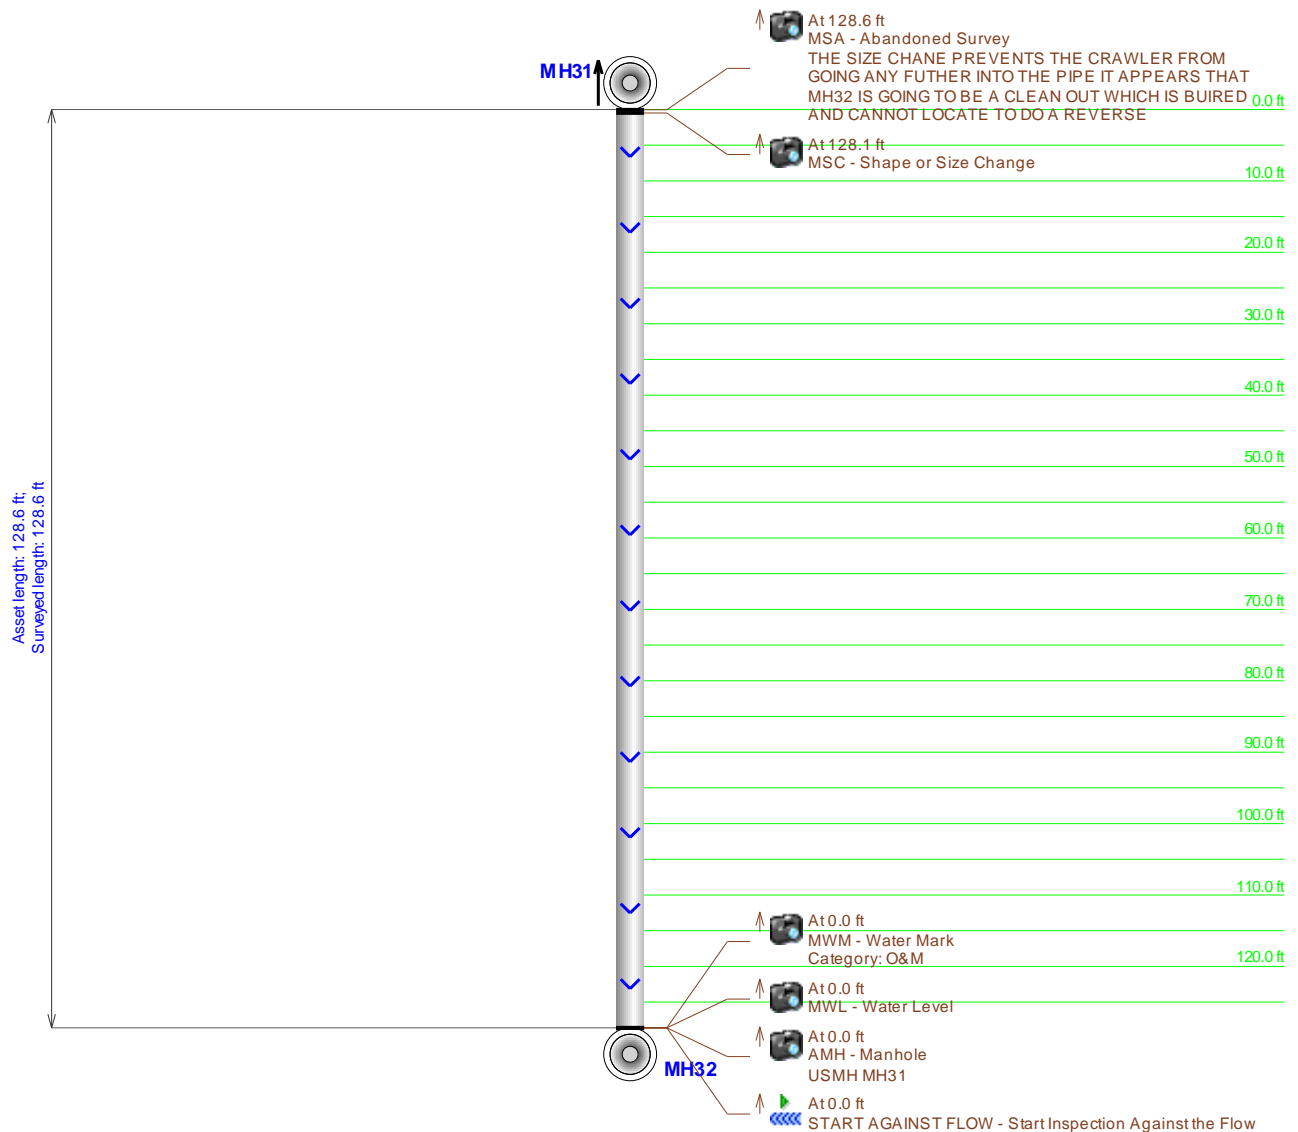
Main Inspection with Pipe-Run Graph

Project Name: CRAFTON HILLS COLLEGE	Pipeline segment ref: MH31-MH32	City: YUCAIPA	Street: CRAFTON HILLS MATIENCE ROAD
Start date/time: 9/29/2015	Width: 	Height: 8	Material: PVC
Direction: UPSTREAM	Length surveyed: 128.6	Surveyed by: R.ZIEGLER	Location code: C
		Weather: 1	
Additional info:

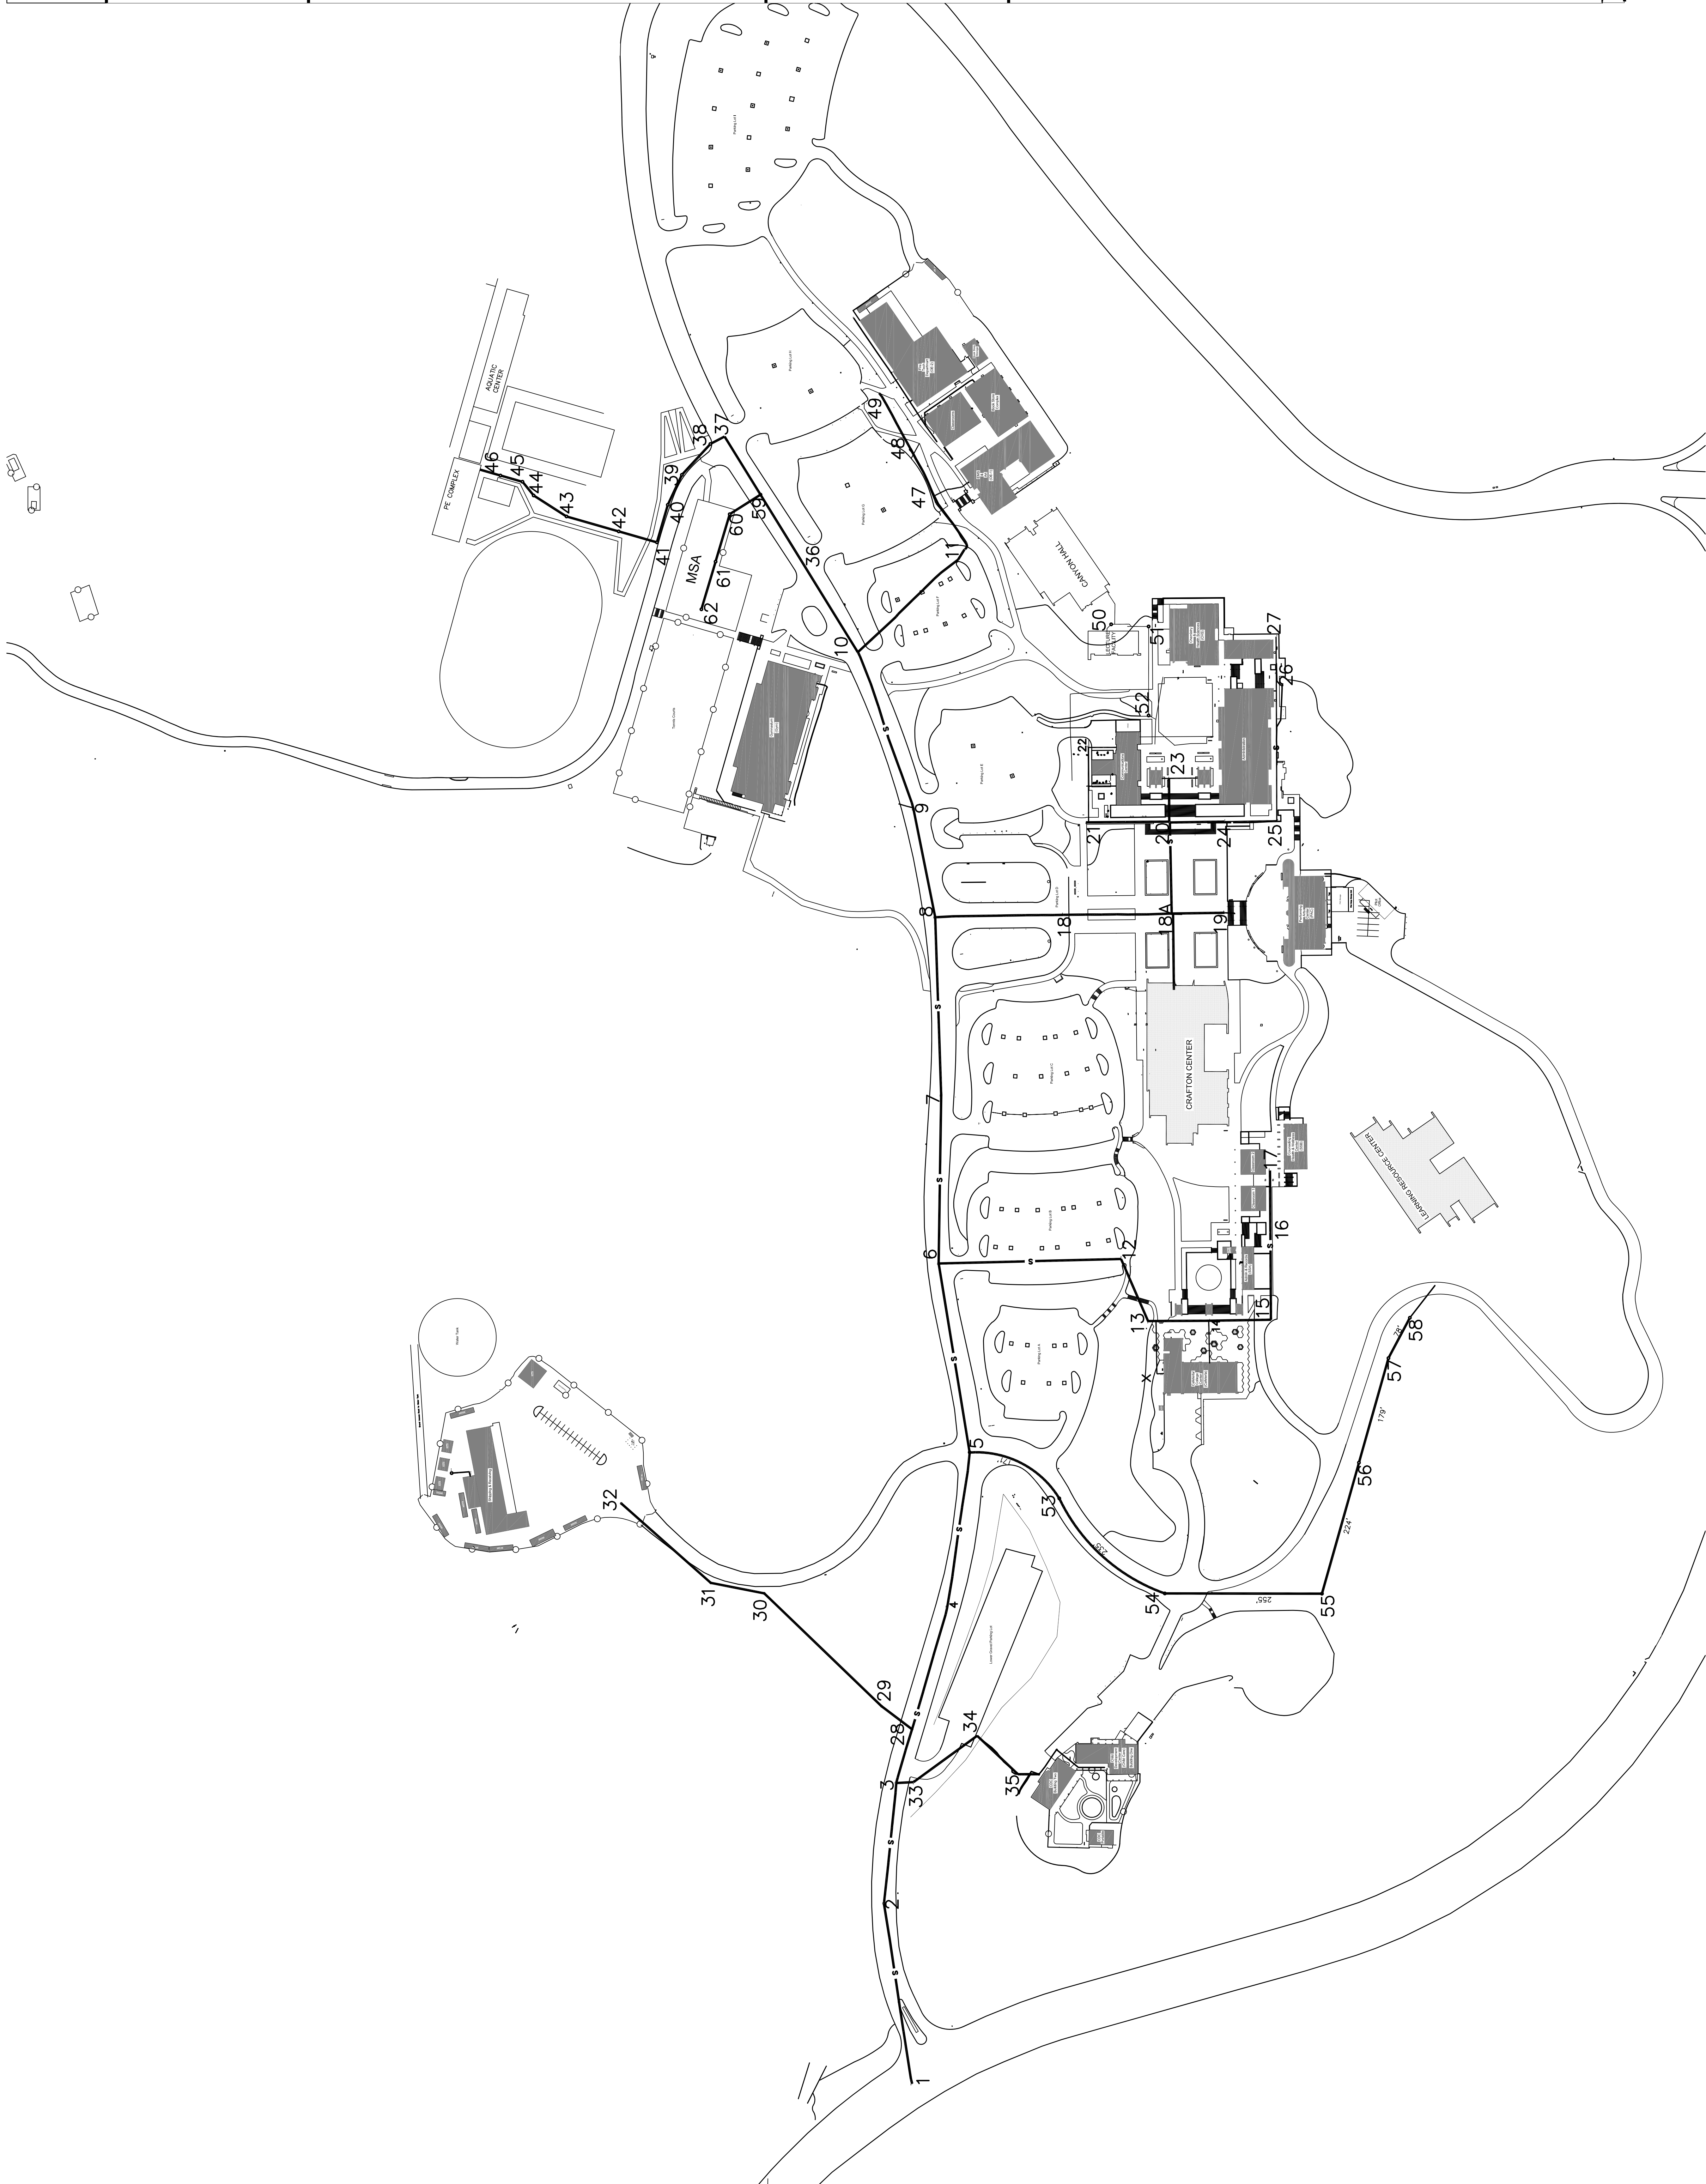
NOTE:
ADD 1000 FEET
TO ALL ELEVATIONS

SEWER SYSTEM EVALUATION	SAN BERNARDINO VALLEY COLLEGE FUTURE CONDITIONS
RESIGNER: NKL/A	JOB NAME
DESIGNER: BW	DATE: 11/07/12
CHECKED: RLB/LANK	
BY:	
NO. DATE:	REVISION DESCRIPTION:
BY:	
NO. DATE:	
SNIPES-DYE ASSOCIATES	
8348 CENTER DRIVE, SUITE G, LA MESA, CA 91942-2910 (619) 697-9234, FAX (619) 460-2033	
SHEET E-2	SHEETS
OF	SUB NO.
